## X-ray quiz: a woman with knee pain

KH Lau 劉廣雄 and CH Chung 鍾展鴻

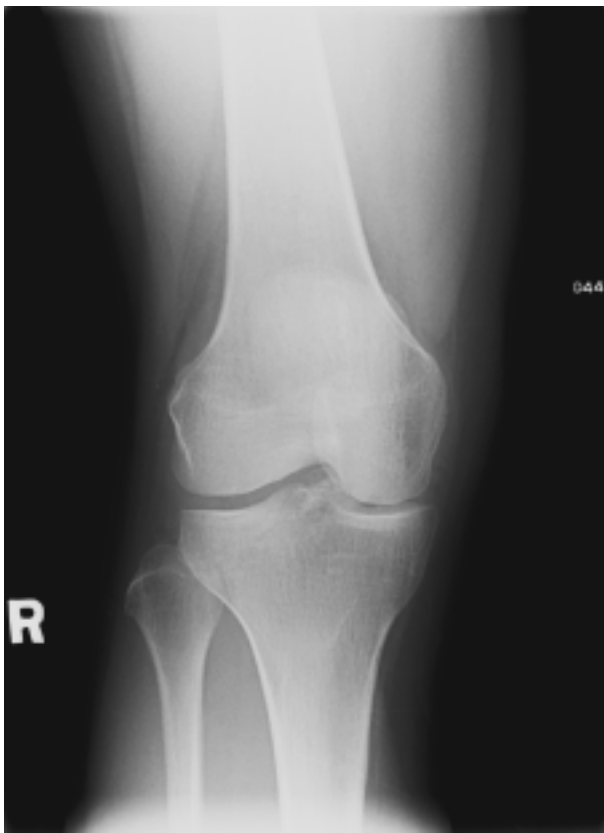
Figure 1a. Anteroposterior view of right knee.

tenderness and swelling were noted at the anteromedial aspect of her right knee. The anterior drawer test, valgus and varus stress tests were all negative. However, pain might have affected the accuracy of these tests. Anteroposterior (AP) and lateral X-rays of the right knee were taken (Figures 1a & 1b).

1. The abnormality is avulsion fracture of the tibial spine, with a bony fragment seen in both the AP and lateral views.
2. The diagnosis is anterior cruciate ligament injury.
3. Possible associated radiographic findings are: -
  - Anterior displacement >5 mm of the tibia relative to the femur on lateral view (tibial anterotranslation)
  - Segond fracture (Avulsion fracture of the lateral tibial condyle)
  - Fracture of the fibular head
  - Nondisplaced fracture of the posterior tibial plateau
  - Lipohaemarthrosis
  - Deepened lateral femoral condylar notch<sup>1</sup>

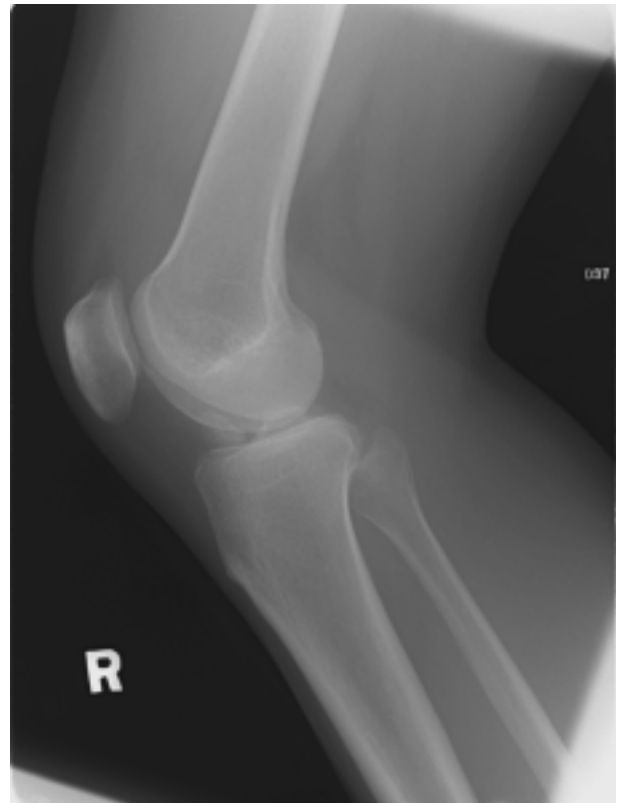
Figure 1b. Lateral view of right knee.
